Public Health Assessment Gulfco Marine Maintenance Freeport, Brazoria County, Texas CERCLIS NO. TXD055144539

April 19, 2004

Prepared by:
The Texas Department of Health
Under Cooperative Agreement with the
Agency for Toxic Substances and Disease Registry

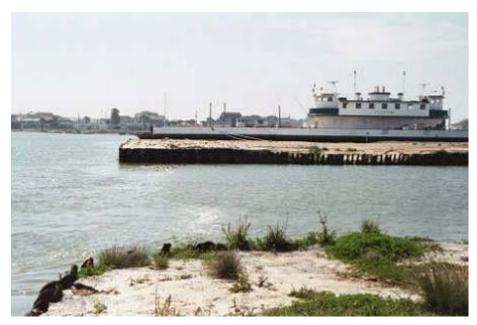
Figure 2 Barge slip adjacent to site (southwest side) showing proximity of residential area in far background

From 1971-1979, the Gulfco facility was used as a barge cleaning and waste disposal facility (Figure 2). Fish Engineering purchased the property in 1979 and continued barge cleaning operations until 1981. Barges brought to the facility were cleaned of waste oils, caustics, and organic chemicals. The wash waters generated during these operations were reportedly stored in three surface impoundments [2]. These surface impoundments are described in a July 15, 1980 U.S. Environmental Protection Agency Site Inspection Report as lined, earthen lagoons with a natural site clay layer [3]. The three impoundments had dimensions ranging from 145-317 feet long by 147-173 feet wide. No depths for the surface impoundments are indicated. In 1982, the impoundments reportedly were closed and covered with a hardwearing surface (Figure 3) [2].

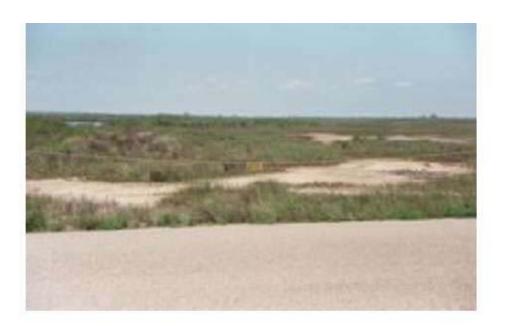
Figure 3 Vacant lot across Marlin Ave. north of site (PPE 2)

Two waste source areas were identified during these inspections. The first, Source 1, consisted of contaminated soil associated with barge cleaning operations. The second, Source 2, consisted of three surface impoundments (buried/backfilled) north of Marlin Avenue (Figures 3, 4, and 5).

On the basis of site descriptions, we concluded that these areas were the Source 2 former surface impoundments (Figure 3) [2].

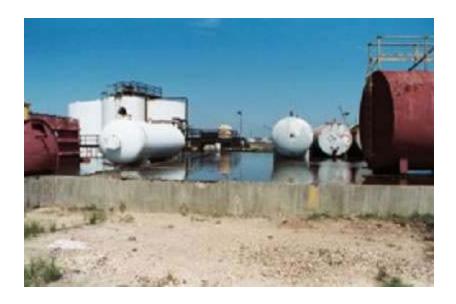
Figure 4. North side of Gulfco site south of Marlin

In January 1989, Fish Engineering sold the majority of the former Gulfco property to Hercules Offshore Corporation that conducted barge cleaning and refurbishing operations at the facility until the company declared bankruptcy in May 1998 [4]. Waste wash waters generated during barge cleaning operations were stored in a rented floating barge or in aboveground storage tanks located on the facility (Figures 4 and 5) [5].

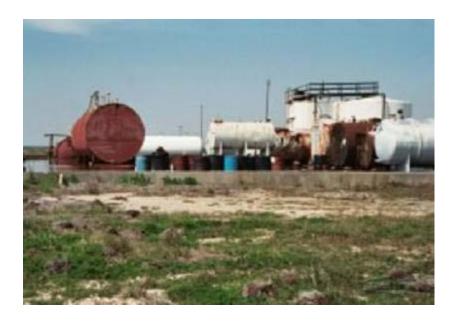
Figure 5. South end of Gulfco site along the Intracoastal Waterway showing storage drums and tanks

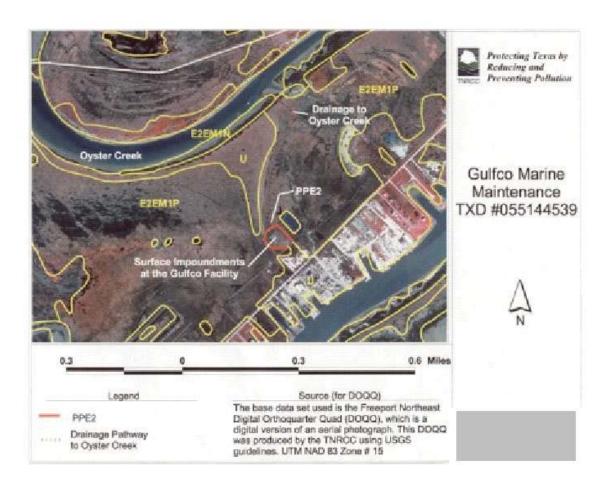
Figure 7. Probable point of entry 2 to Oyster Creek

Areas of the Gulfco property north of Marlin Avenue drain to the northeast into an estuarine, persistently flooded wetland. These wetlands are directly adjacent to the Source 2 surface impoundments. The off-site drainage pathway from the Source 2 surface impoundments is northeast toward Oyster Creek (Figure 7).

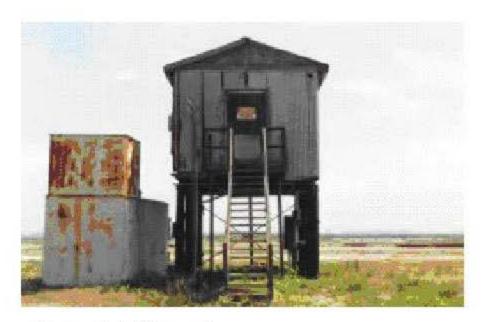
Figure 8. Tin building on site

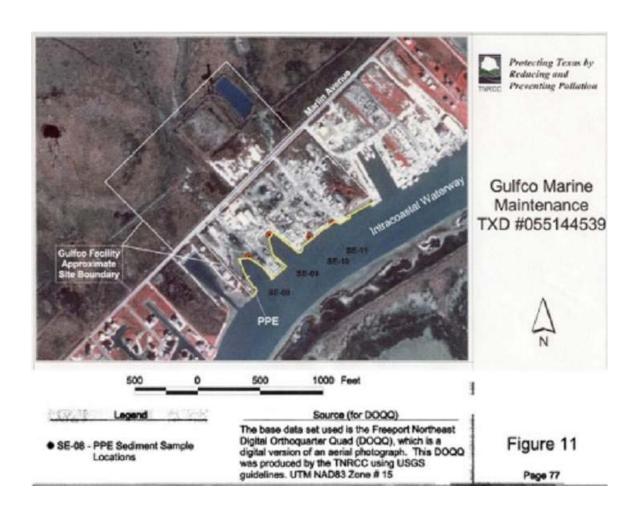
Figure 10. Probable point of entry 1
